Sample Site, Sample Street, Anytown, UK

Reference:
Sample_Siteview
Your reference:
Sample_Siteview

Professional opinion

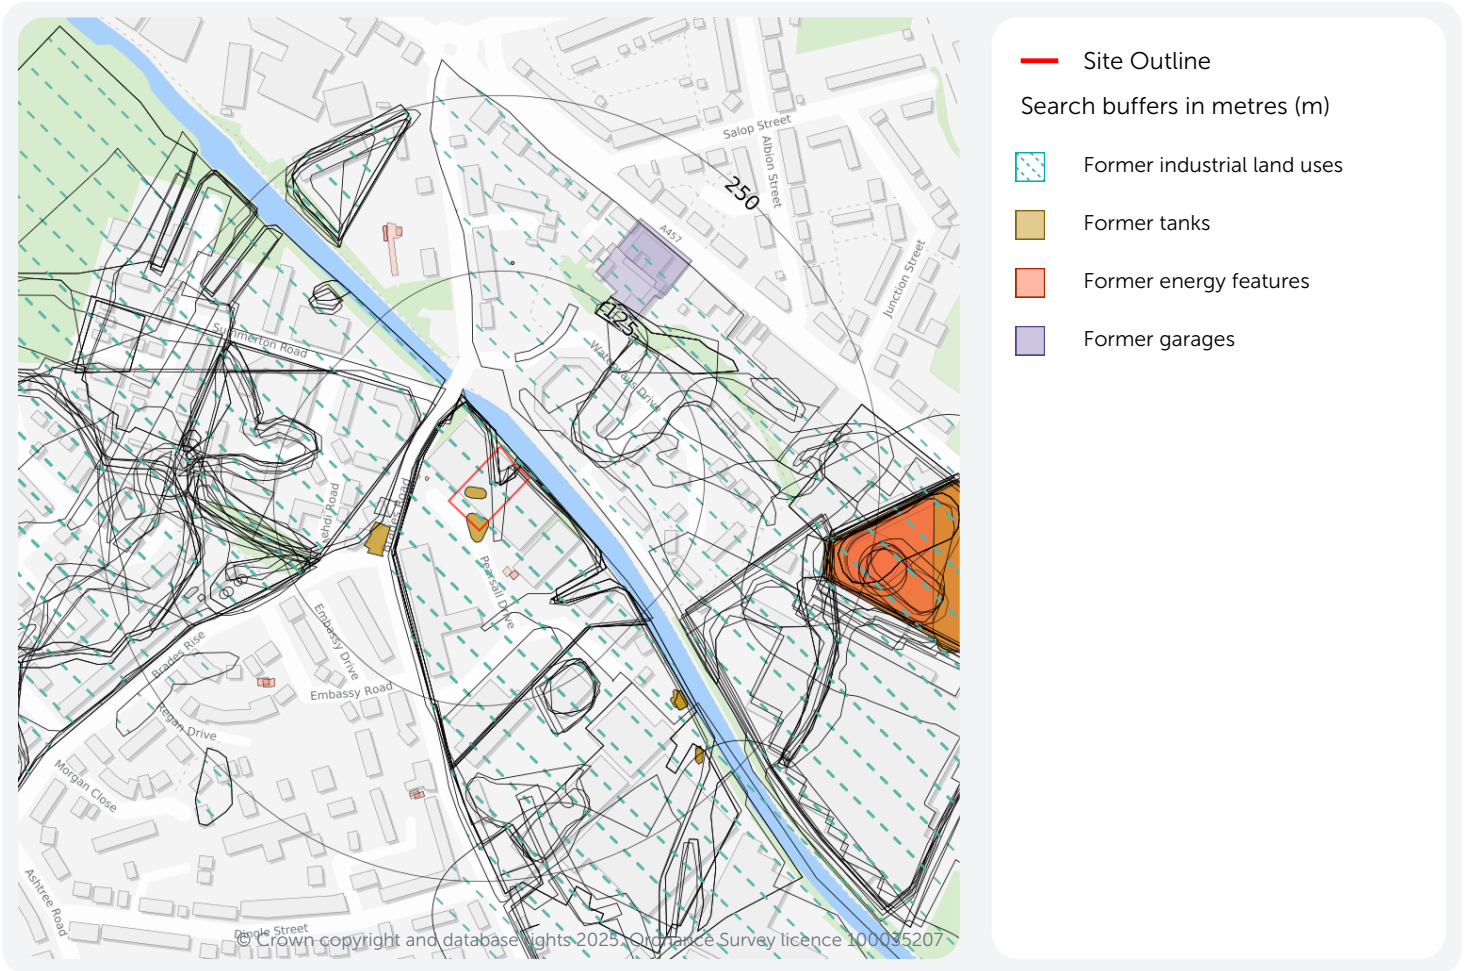
Former industrial land use (1:10,560 and 1:10,000 scale)

These historical land uses have been identified from 1:10,560 and 1:10,000 scale Ordnance Survey maps dated from the mid to late 1800s to recent times. They have the potential to have caused ground contamination. Please see the Environmental Summary to find out how these could impact the site.

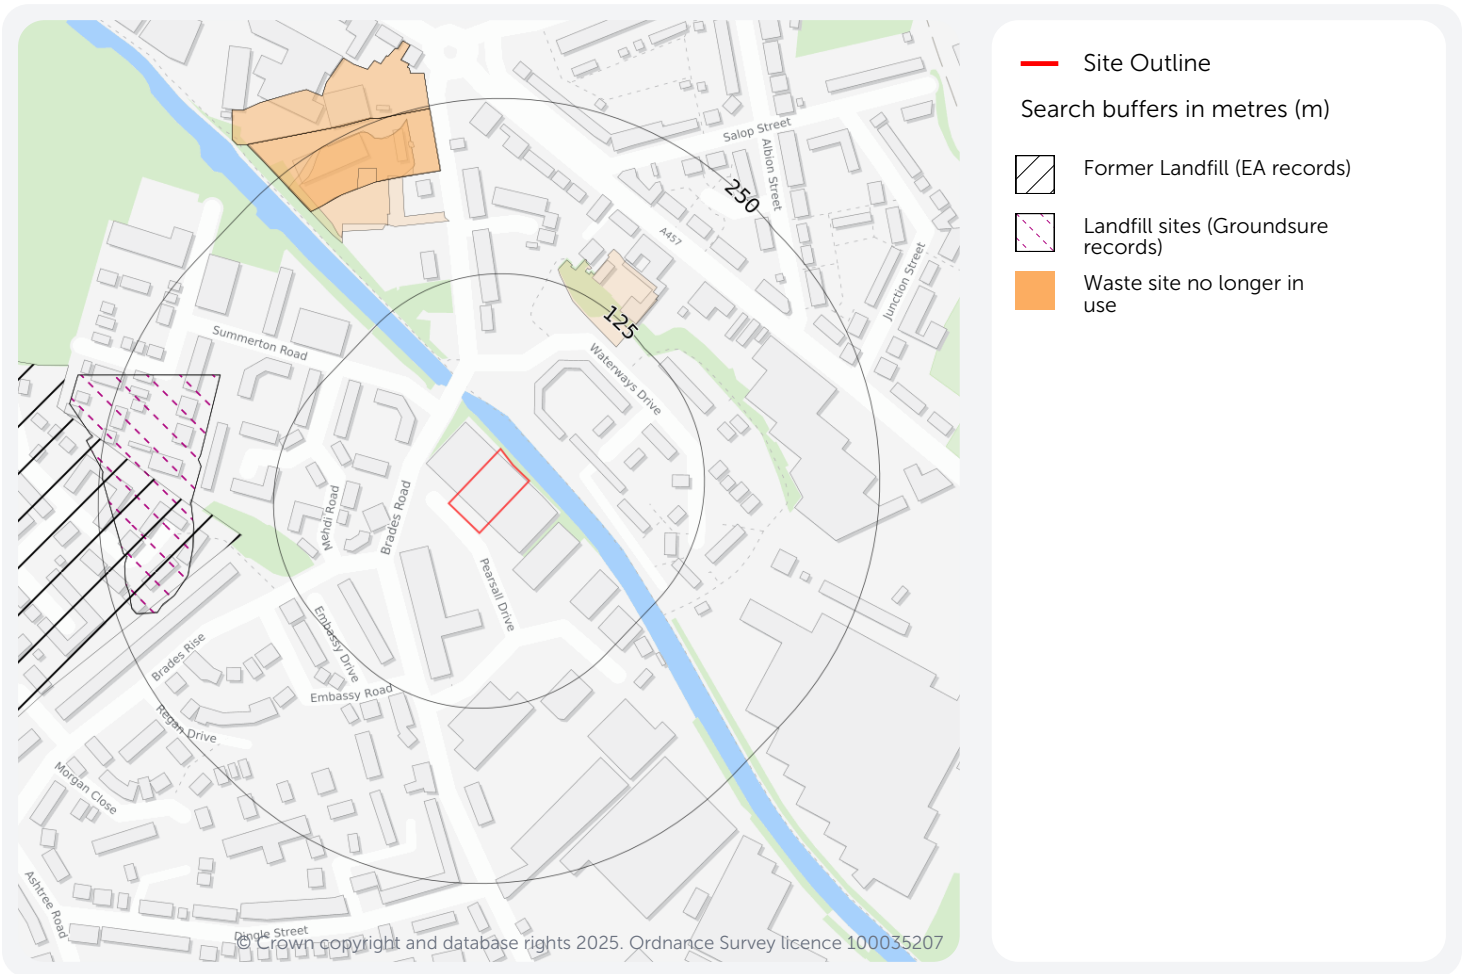
Former landfill (from Local Authority and historical mapping records)

These are records of former areas of landfill. These areas of land may have been redeveloped for other uses since the landfill closed. Depending on the nature of the waste these landfill sites accepted, they may still pose a risk of contamination (including from landfill gases). Former landfill sites can also cause issues with ground instability.

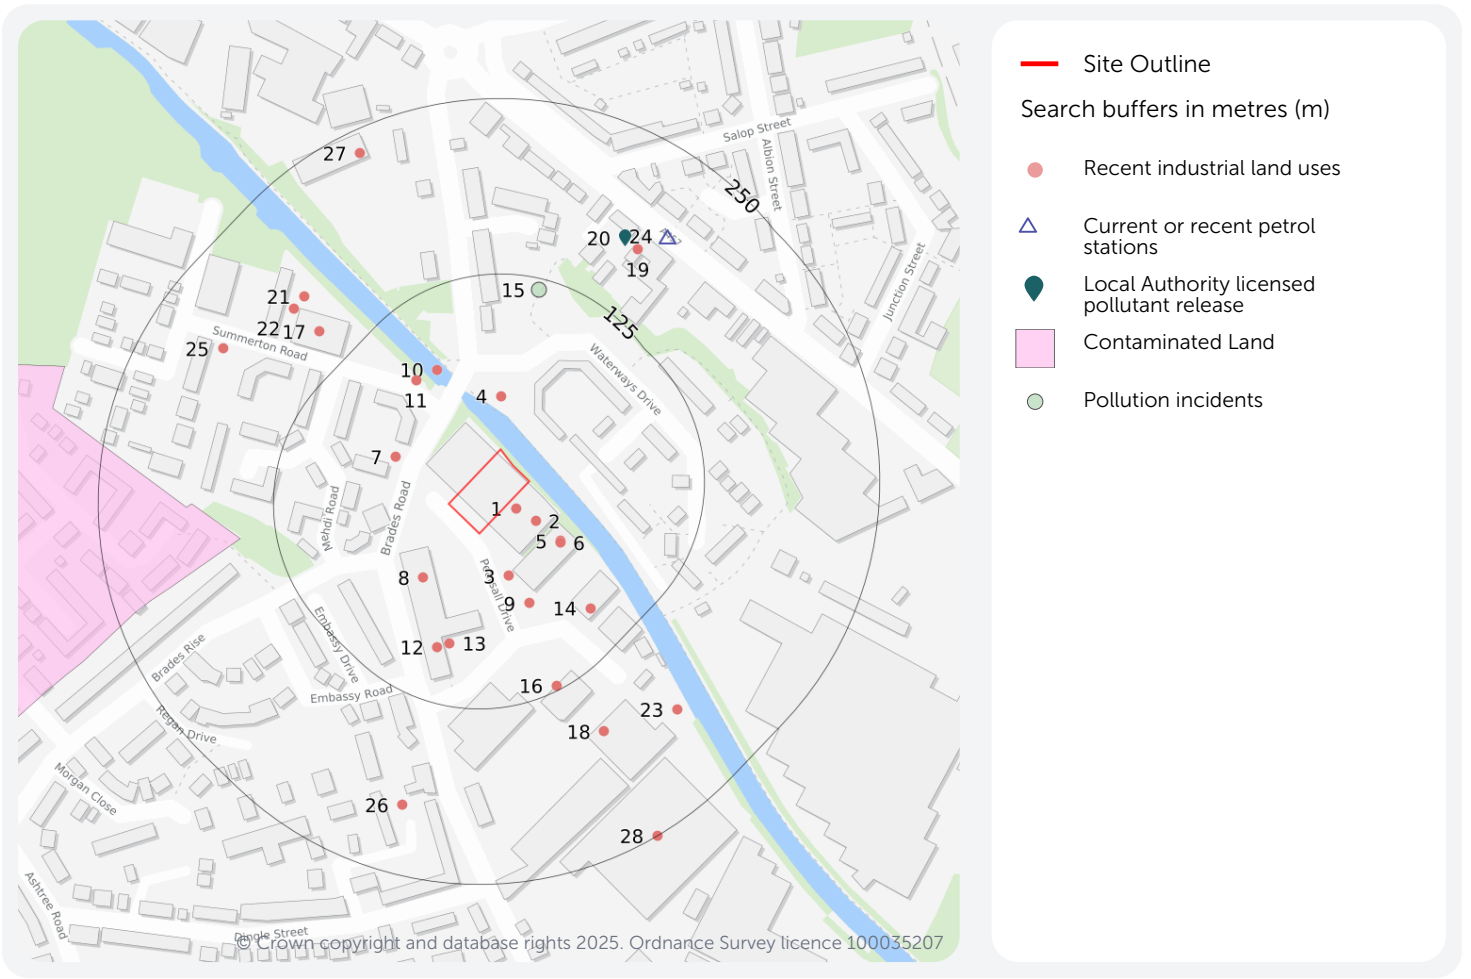
Recent industrial land uses

These records show details of businesses that have recently operated, or are currently operating in the area. Depending on the type of activities taking place, some of these businesses could present a risk of contamination.

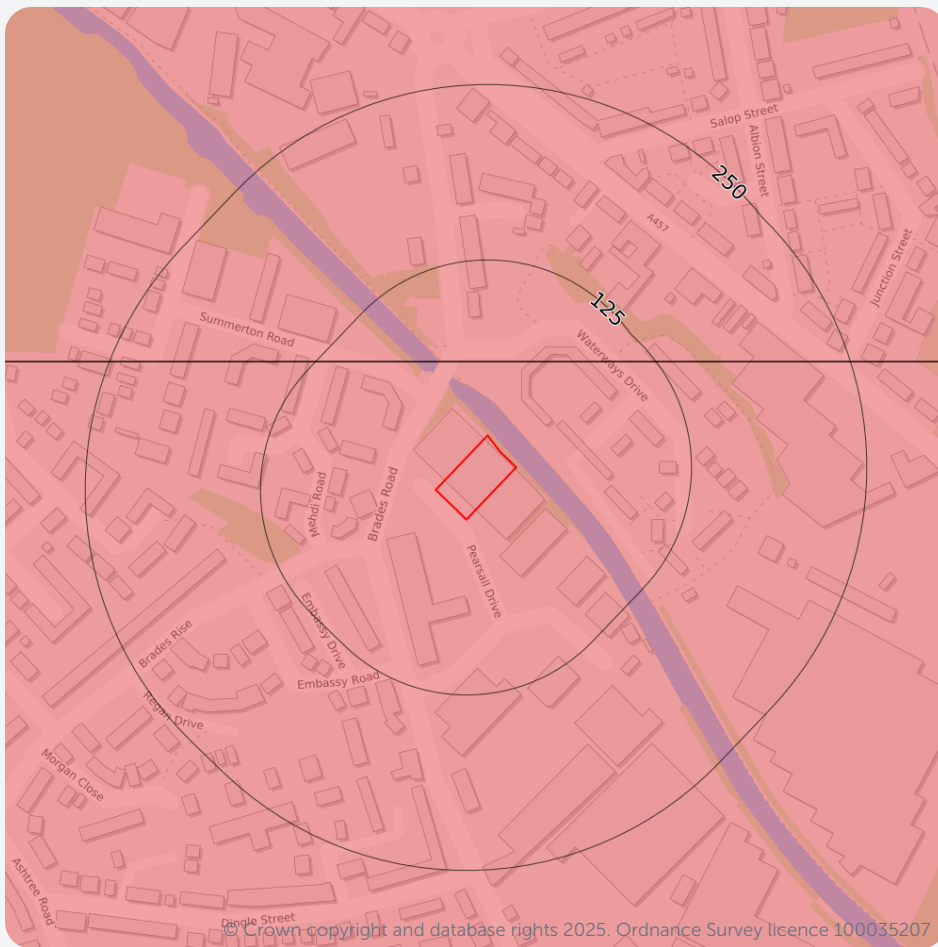
Aquifers within bedrock geology

- Site Outline
- Search buffers in metres (m)
- Principal
- Secondary A
- Secondary B
- Secondary Undifferentiated
- Unproductive
- Groundwater abstraction licence (point)
- Groundwater abstraction licence (area)
- Groundwater abstraction licence (linear)

The Environment Agency/Natural Resources Wales and the British Geological Survey have assigned designations or types to the aquifers that exist within bedrock geology. These designations reflect the importance of aquifers in terms of groundwater as a resource (eg drinking water supply) but also their role in supporting surface water flows and wetland ecosystems.

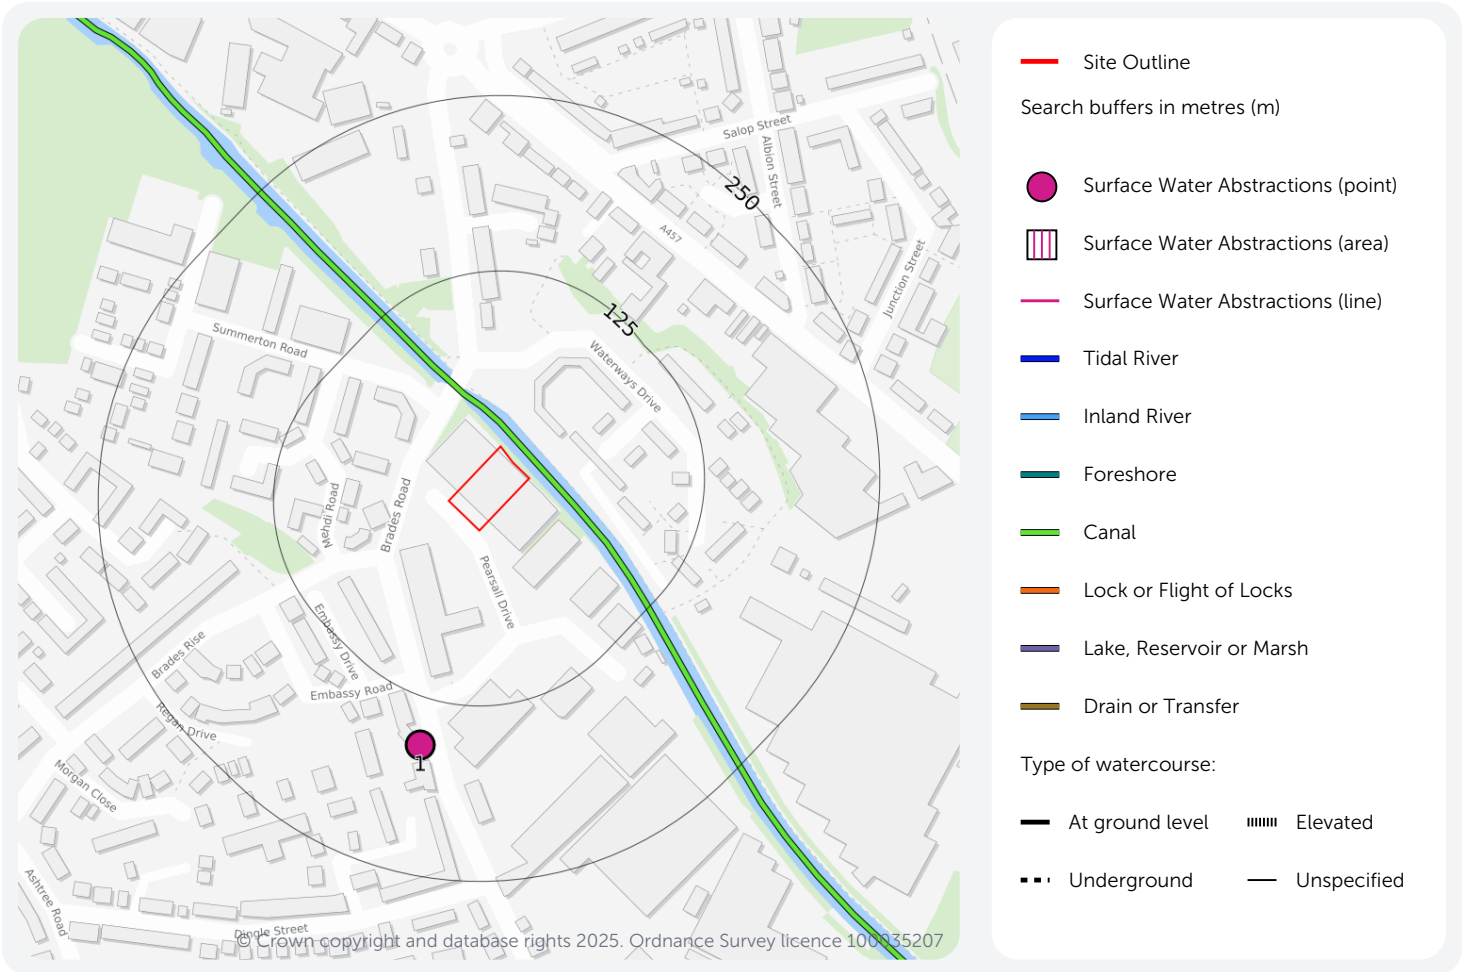
Water courses from Ordnance Survey

These are water features such as ponds, lakes, rivers and streams that have been identified by Ordnance Survey. These features may be sensitive to contamination.

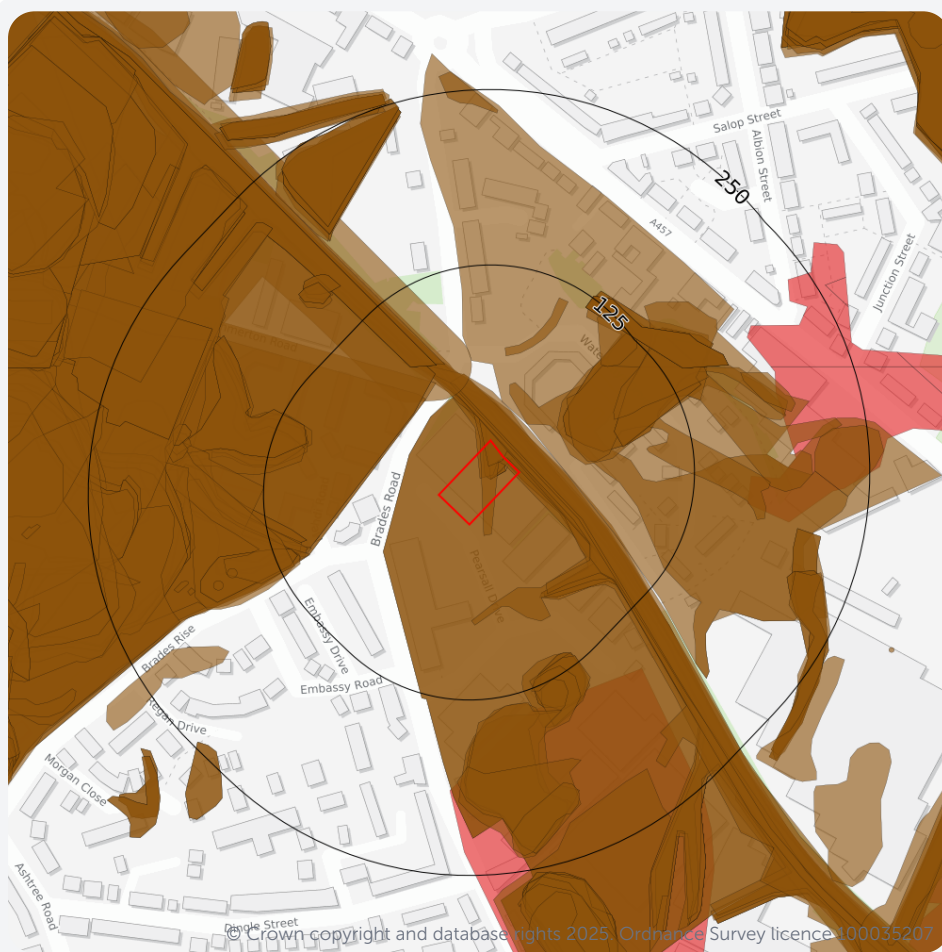
— Site Outline
Search buffers in metres (m)

■ Infilled Land

The property is located in an area that may be affected by surface or sub-surface coal mining. Mining may cause ground stability problems such as subsidence, surface collapses, mass movement and landslides, depending on the style of mining used.

The property is located in an area that may be affected by surface or sub-surface mining of materials other than coal. Mining may cause ground stability problems such as subsidence, surface collapses, mass movement and landslides, depending on the style of mining used.

Maps suggest the property is located on a previous pond, quarry, mine, landfill or other hole in the land. These land cavities are often filled in with various materials and this can cause structural problems, although such events are rare. Groundsure's experts recommend that you check whether your structural surveys have taken this into account.
